Flood Control Project Maintenance**2013 Structure Summary Report****Overall Unit and Item Ratings****DWR Sutter Maintenance Yard****Butte Slough Drainage Structure**

Flood Control Project Maintenance
2013 Structure Summary Report
Overall Unit and Item Ratings

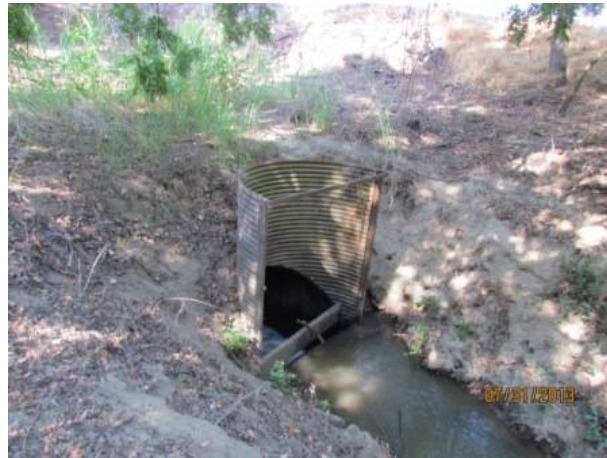
Levee Mile Report Line	1
Start Levee Mile	0.00
End Levee Mile	0.00
Location	
Category	Structures
Item	Photo Documentation
Butte Slough Drainage structure on the land side.	
mkhashch_t_20130731_101.JPG

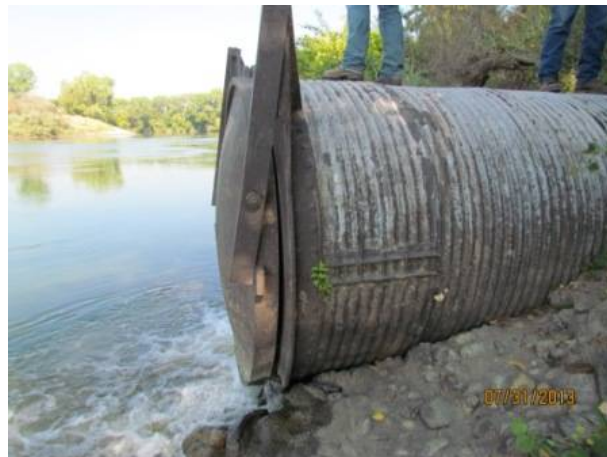
Levee Mile Report Line	1
Start Levee Mile	0.00
End Levee Mile	0.00
Location	
Category	Structures
Item	Photo Documentation
Butte Slough Drainage structure outfall.	
mkhashch_t_20130731_102.JPG

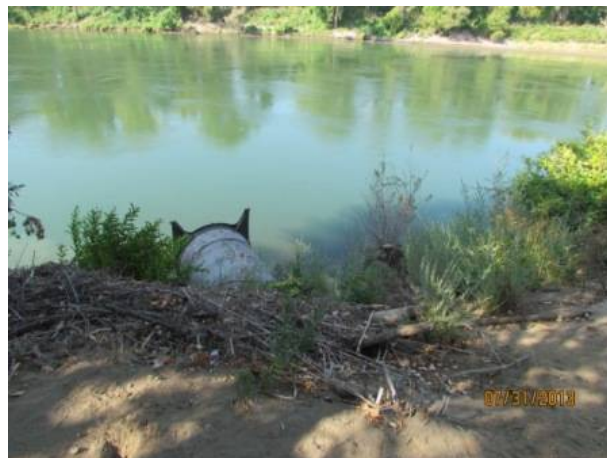
Levee Mile Report Line	1
Start Levee Mile	0.00
End Levee Mile	0.00
Location	
Category	Structures
Item	Photo Documentation
Butte Slough Drainage structure on the water side.	
mkhashch_t_20130731_103.JPG

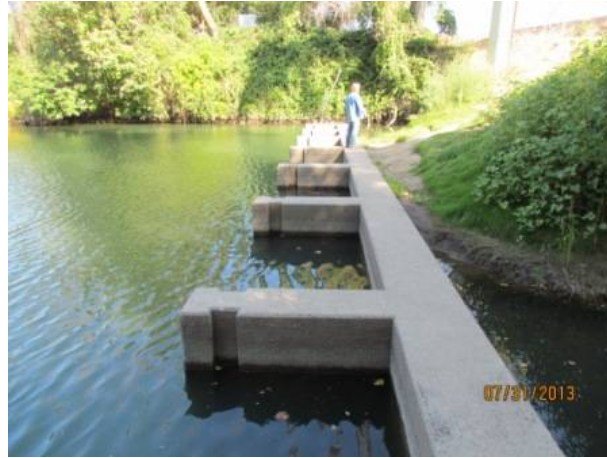
mkhashch_t_20130731_099.JPG

View of the Butte Slough Outfall Structure on the water side.

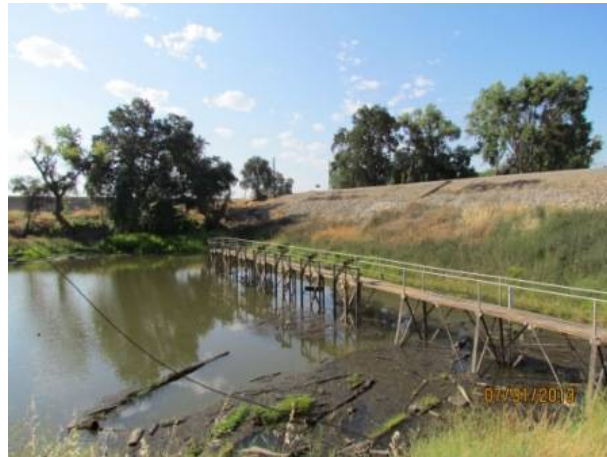
mkhashch_t_20130731_100.JPG

View of the Butte Slough Outfall Structure on the land side.

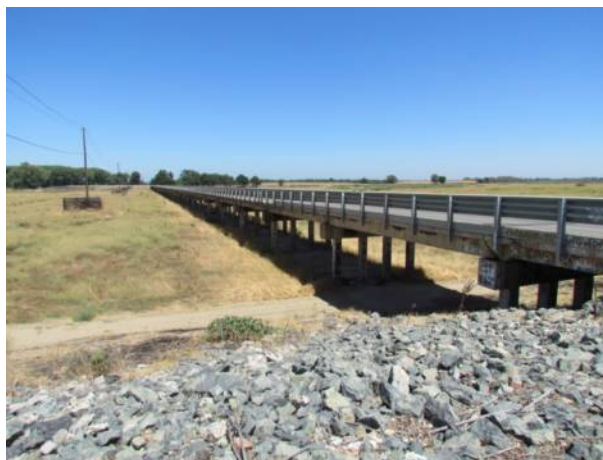
mhoffman_t_20130807_054.JPG

This view is of the Colusa Weir structure from the right bank of the levee.

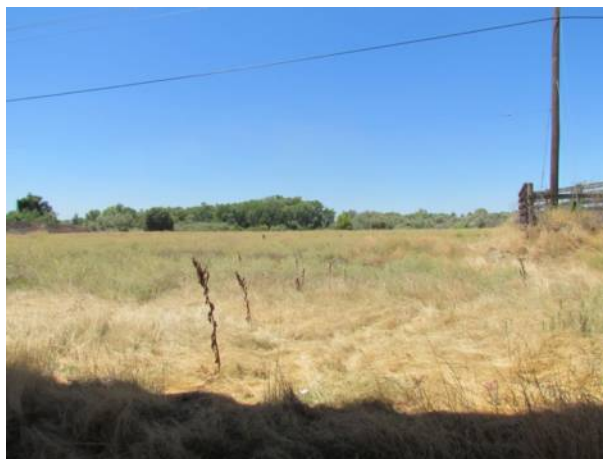
mhoffman_t_20130807_055.JPG

This is the upstream view of the Colusa Weir structure.

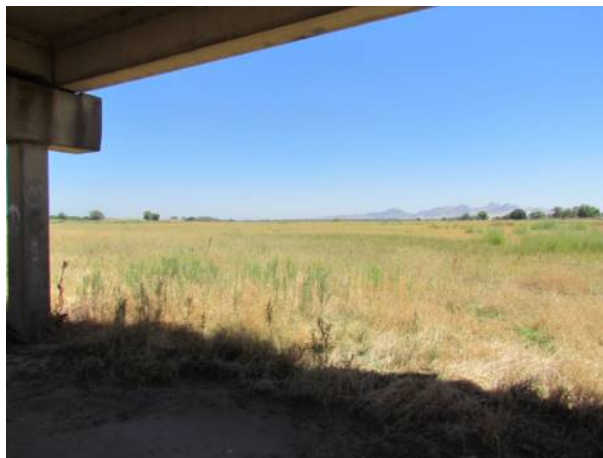
mhoffman_t_20130807_056.JPG

This is the downstream view of the Colusa Weir structure.

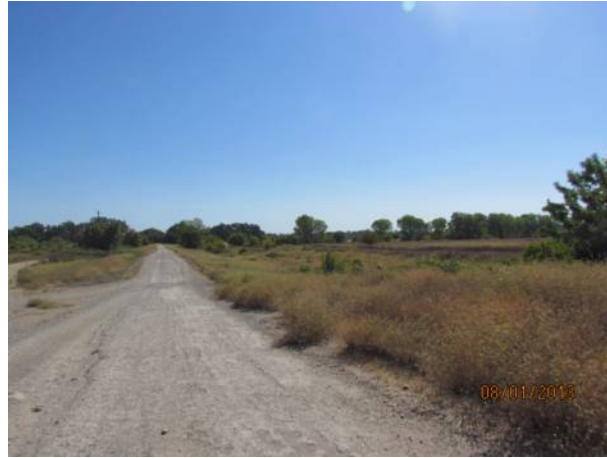
rduffey_t_20130827_012.JPG

View of the vegetation on both sides of the weir.

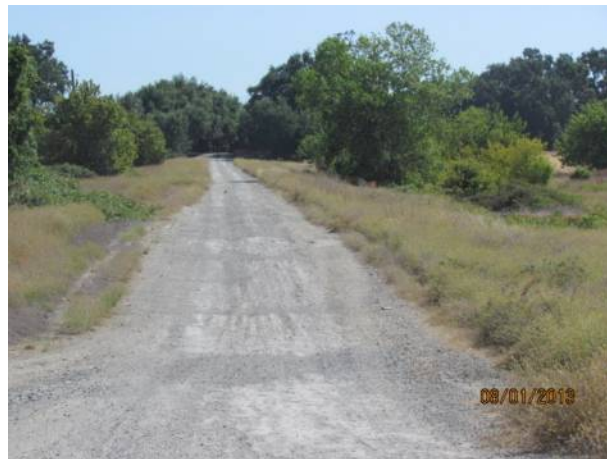
rduffey_t_20130827_013.JPG

View of the concrete crown roadway on top of the weir.

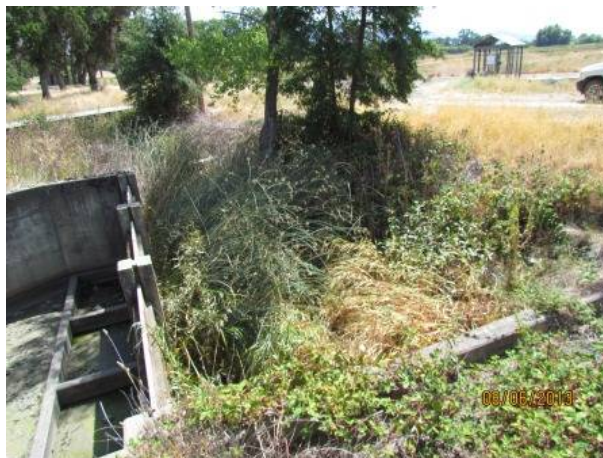
pkazi_t_20130820_316.JPG

View of the vegetation growth on the inlet of the structure.

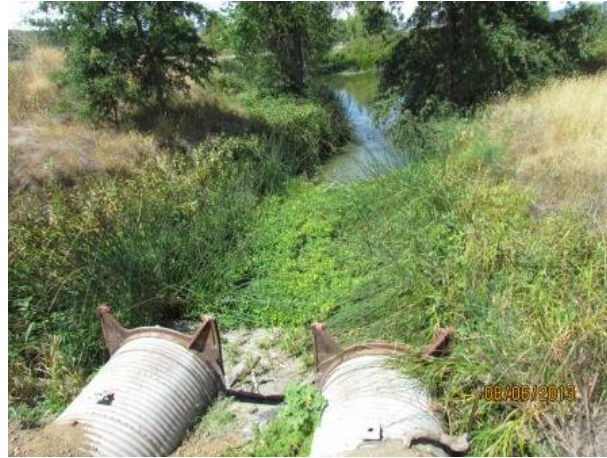
pkazi_t_20130820_317.JPG

View of vegetation on the outlet of the structure.

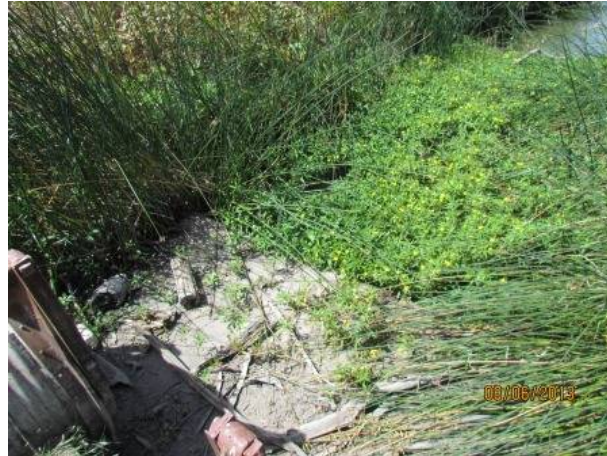
pkazi_t_20130820_318.JPG

View of the debris at the culvert outlet.

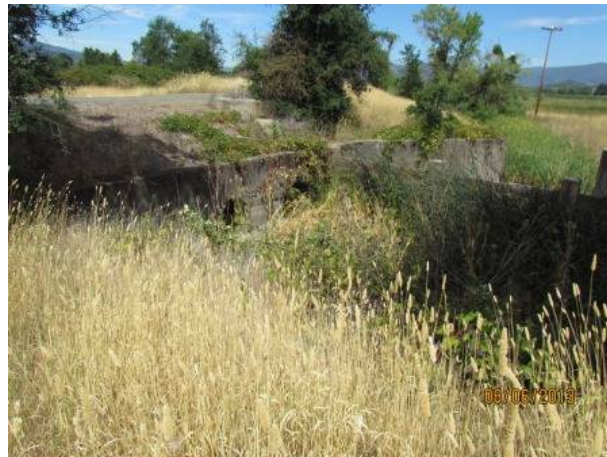
pkazi_t_20130820_319.JPG

View of the vegetation at the inlet of the culvert.

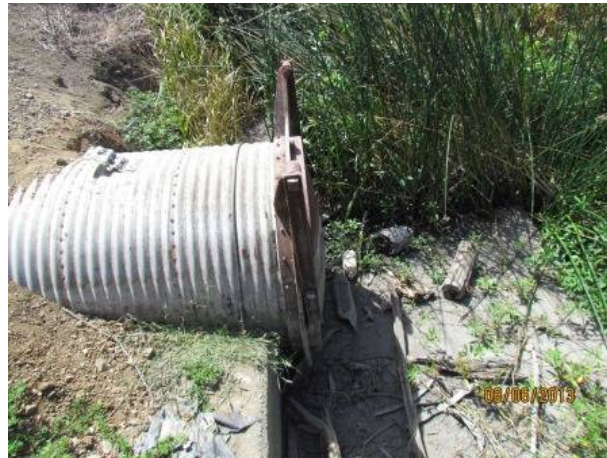
pkazi_t_20130820_321.JPG

View of one of the flap gates.

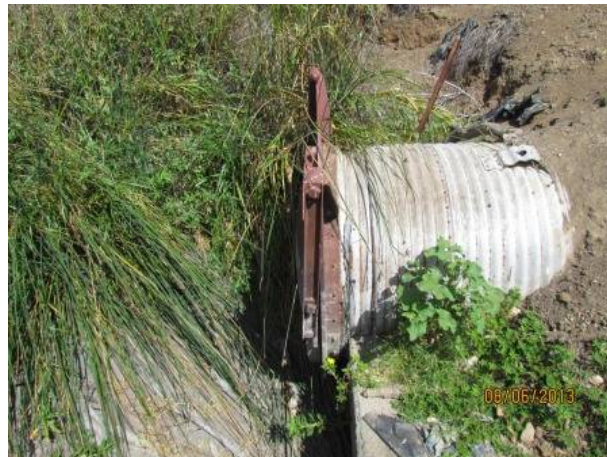
pkazi_t_20130820_322.JPG

View of another flap gate.

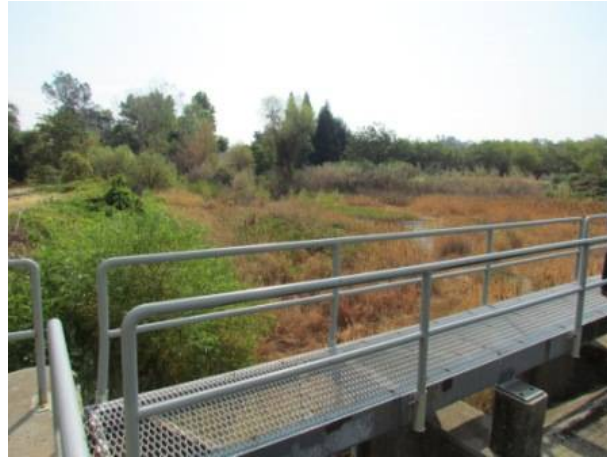
mhoffman_t_20130820_064.JPG

This is a view looking upstream.

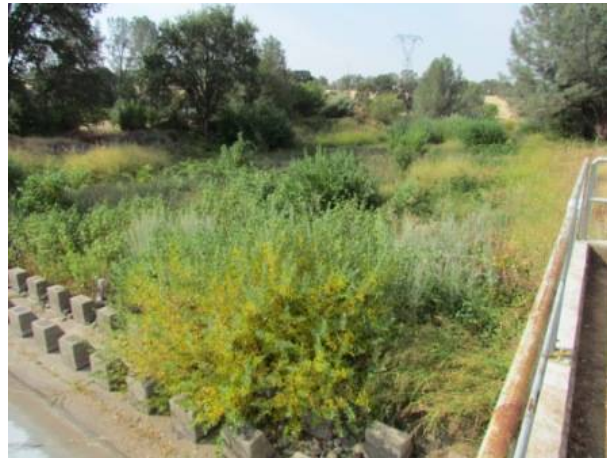
mhoffman_t_20130820_065.JPG

This is a view looking downstream.

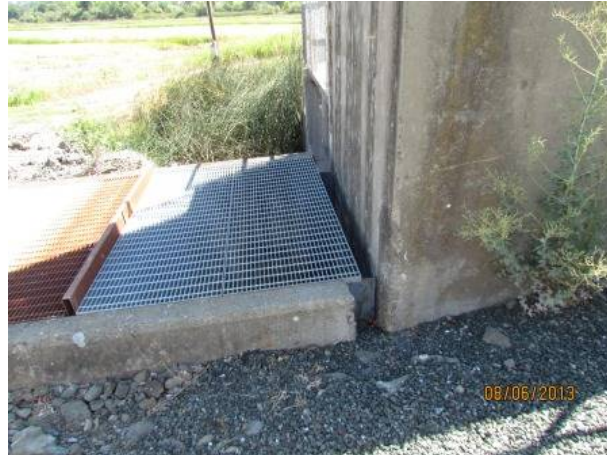
pkazi_t_20130819_291.JPG

View of the settlement next to the pumping plant.

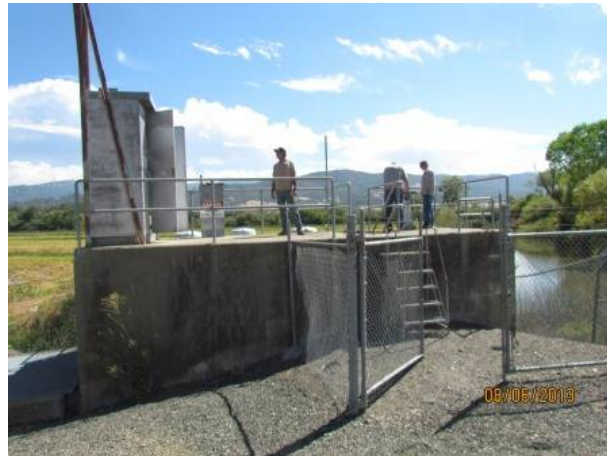
pkazi_t_20130819_293.JPG

View of the guard rails around the pumping plant.

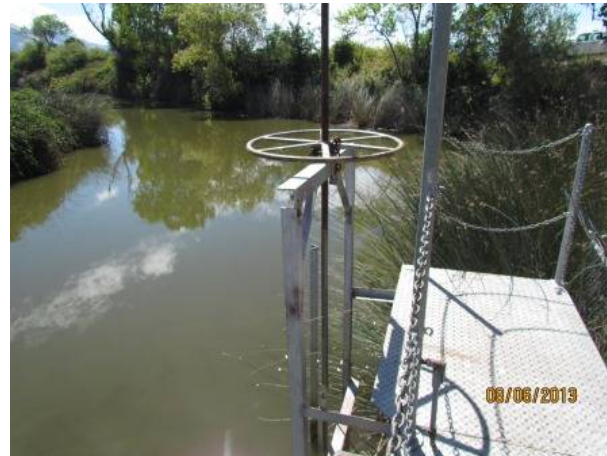
pkazi_t_20130819_302.JPG

View of the manual operator at the plant.

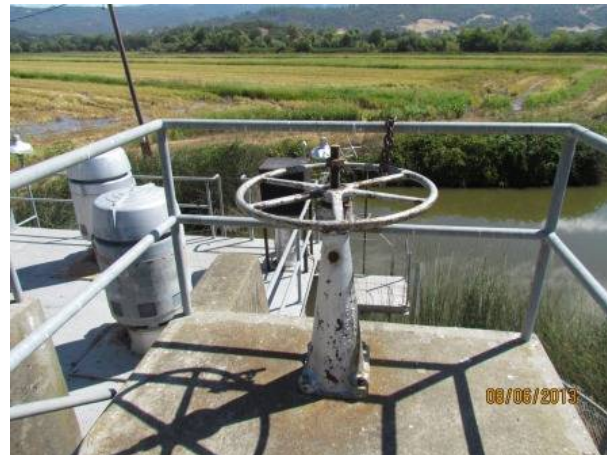
pkazi_t_20130819_303.JPG

View of the manual operator at the plant.

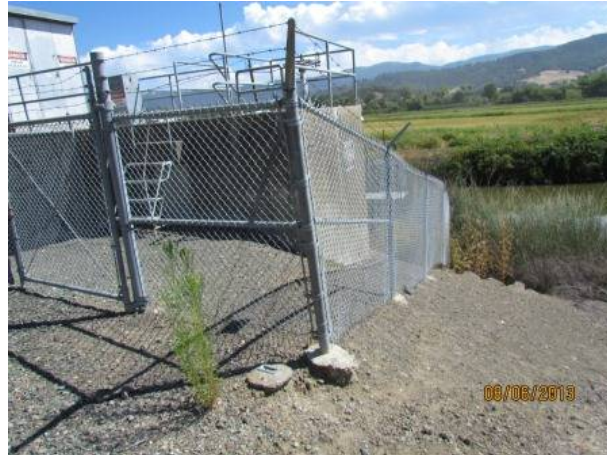
pkazi_t_20130819_304.JPG

View of the security fencing around the plant.

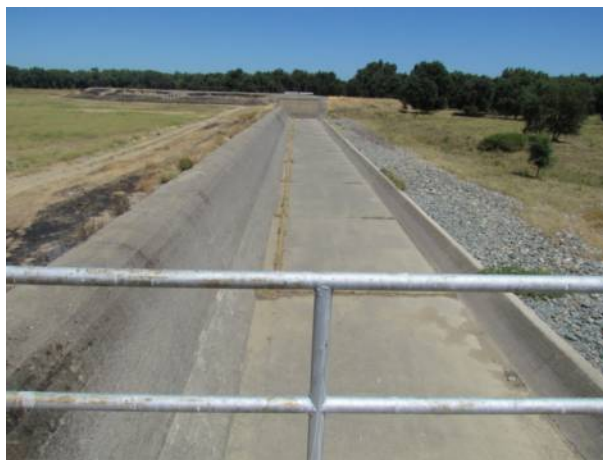
mhoffman_t_20130807_042.JPG

This is a view of the Moulton Weir taken from the right bank levee.

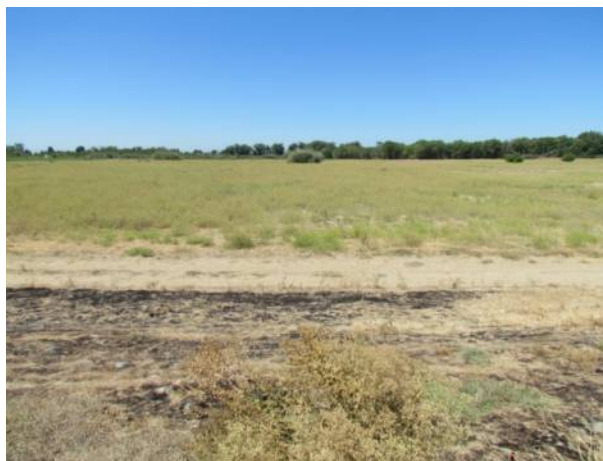
mhoffman_t_20130807_043.JPG

This is an upstream view of the Moulton Weir.

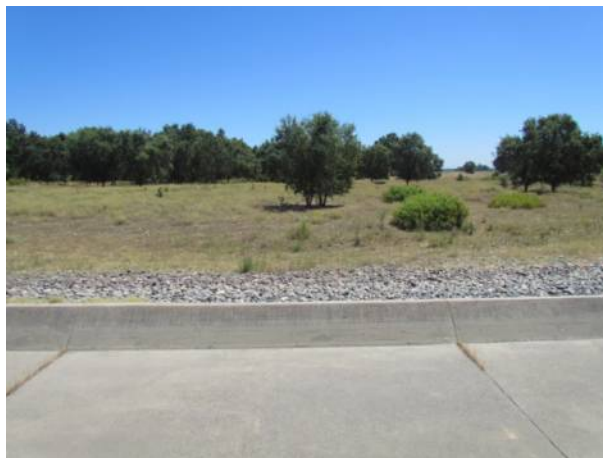
mhoffman_t_20130807_044.JPG

This is a downstream view of the Moulton Weir.

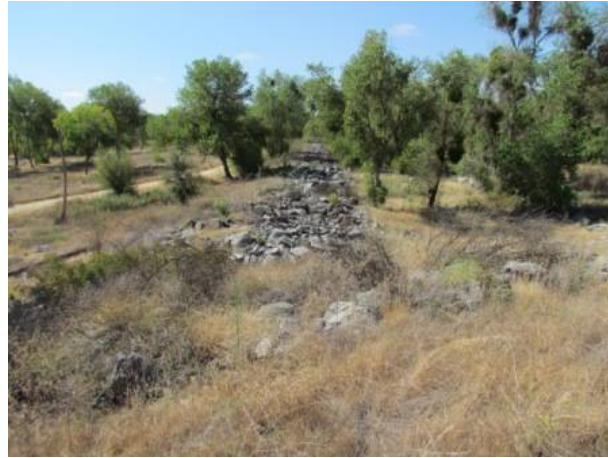
mhoffman_t_20130812_063.JPG

This view is from the north end of the structure looking south.

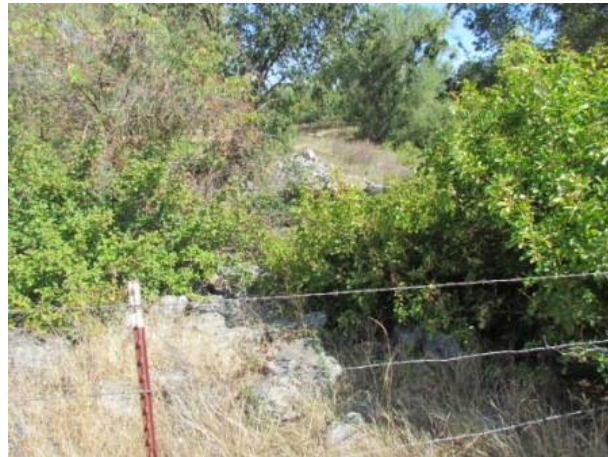
mhoffman_t_20130820_066.JPG

This is a view of the vegetation in and around the weir.

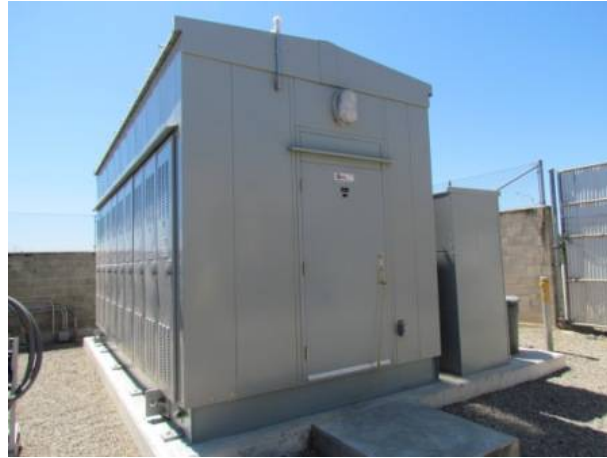
mkhashch_t_20130730_035.JPG

View of plant building under construction.

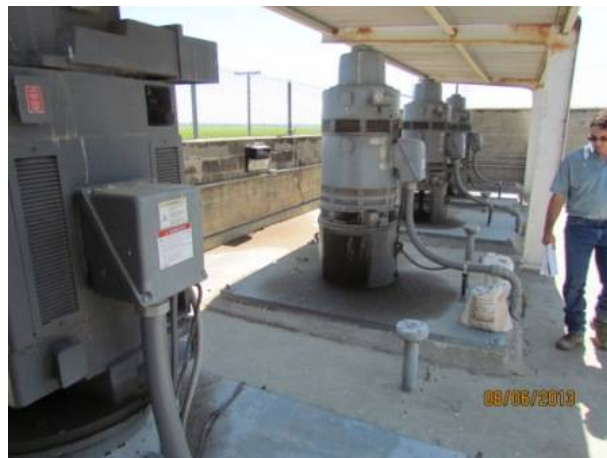
mkhashch_t_20130815_121.JPG

Photo shows pump motors, which appear to be in operating condition.

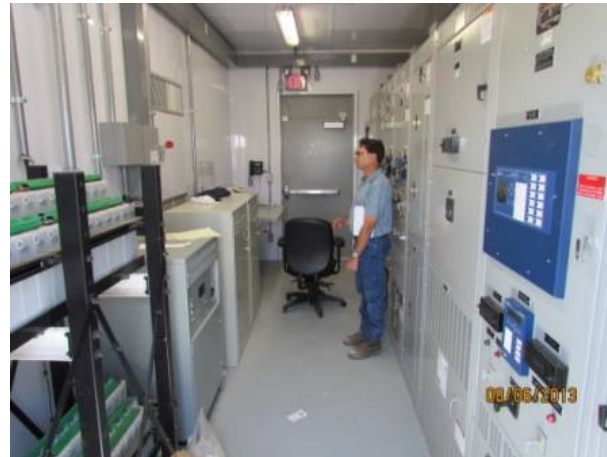
mkhashch_t_20130815_122.JPG

View of the control room.

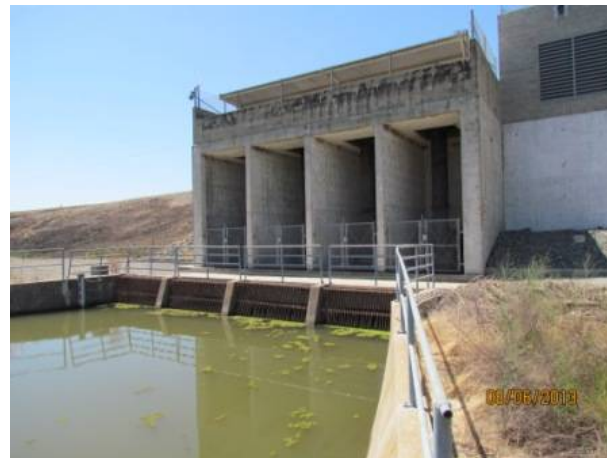
mkhashch_t_20130815_123.JPG

Photo shows properly maintained trash rack.

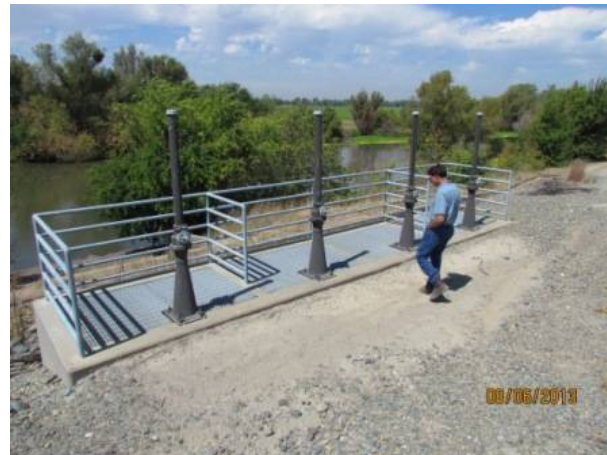
mkhashch_t_20130815_124.JPG

Photo shows sluice gate operators. Note: operators can be operated either mechanically or manually.

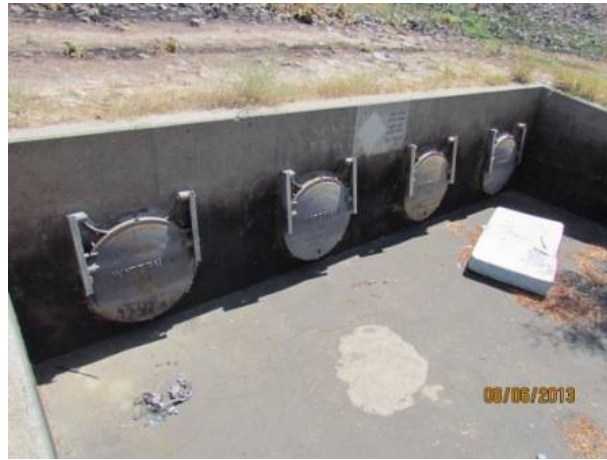
Levee Mile Report Line	18
Start Levee Mile	0.00
End Levee Mile	0.00
Location	
Category	Pump Stations
Item	Flap Gates
Photo shows flap gates and concrete outfall structure.	
mkhashch_t_20130815_125.JPG

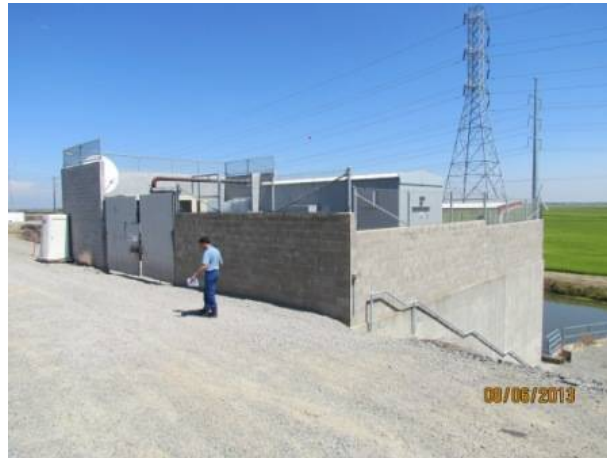
Levee Mile Report Line	20
Start Levee Mile	0.00
End Levee Mile	0.00
Location	
Category	Pump Stations
Item	Security Fencing
Photo shows masonry brick wall which encloses the pump plant.	
mkhashch_t_20130815_126.JPG

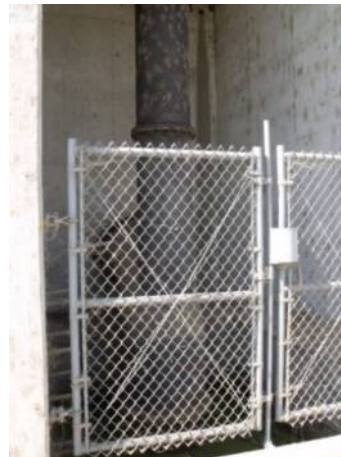
Levee Mile Report Line	21
Start Levee Mile	0.00
End Levee Mile	0.00
Location	
Category	Pump Stations
Item	Intake and Discharge Pipes
08/24/2011 Photo shows pump intake pipe, typical.	
mkhashch_t_20130730_048.jpg

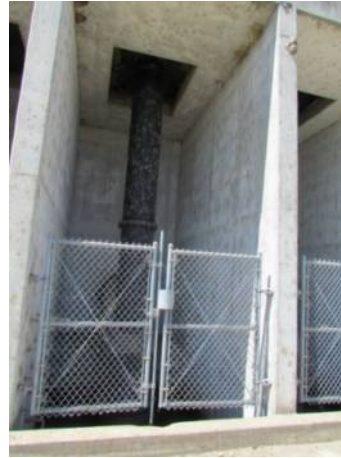
Levee Mile Report Line	21
Start Levee Mile	0.00
End Levee Mile	0.00
Location	
Category	Pump Stations
Item	Intake and Discharge Pipes
07/20/2012 Photo shows pump intake pipe, typical.	
mkhashch_t_20130730_049.JPG

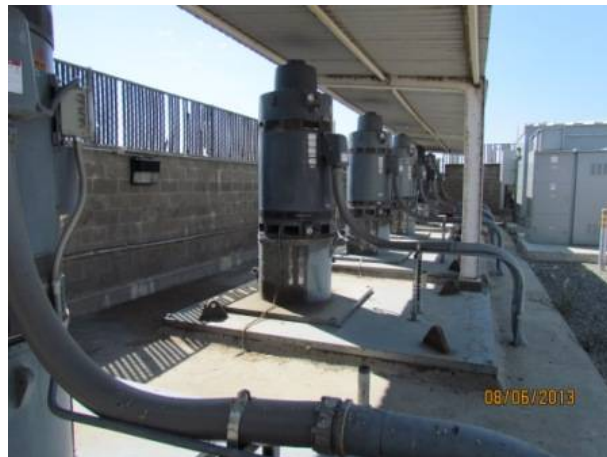
Levee Mile Report Line	7
Start Levee Mile	0.00
End Levee Mile	0.00
Location	
Category	Pump Stations
Item	Pumps
View of the pumps.	
mkhashch_t_20130815_111.JPG

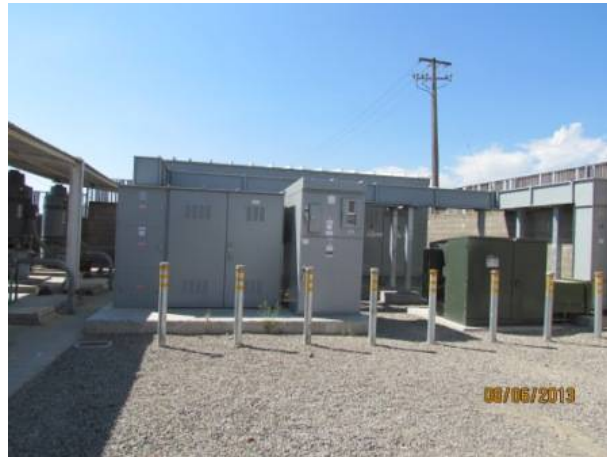
mkhashch_t_20130815_113.JPG

View of the new control building in the background.

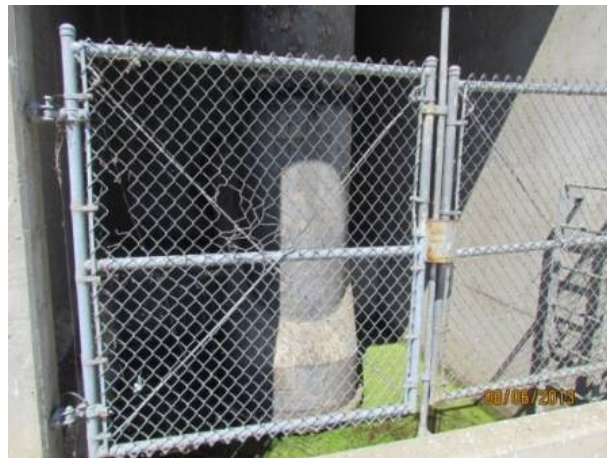
mkhashch_t_20130815_114.JPG

LMR No.	Levee Mile		Category	Item	Location	Rating	Action/Comment	GPS Latitude/Longitude		Issue No.
	Start	End						Start	End	Photo
11	0.00	0.00	Pump Stations	Sumps/Wet Well		A	Inspector Comments: Vegetation noted in one (of six) sumps, but this does not appear to be enough to inhibit pump operation.	39.026350 ° -121.726870 °	39.026350 ° -121.726870 °	12 Y
12	0.00	0.00	Pump Stations	Trash Racks		A	Item inspected visually only. Item was not operated during the inspection. Inspector Comments: Trash rack is secure and free of debris.	39.026350 ° -121.726870 °	39.026350 ° -121.726870 °	13 Y
13	0.00	0.00	Pump Stations	Trash Rakes		N	Item inspected visually only. Item was not operated during the inspection. Inspector Comments: No trash rake at this site.	39.026350 ° -121.726870 °	39.026350 ° -121.726870 °	14
14	0.00	0.00	Pump Stations	Sluice / Slide Gates		A	Item inspected visually only. Item was not operated during the inspection. Inspector Comments: Sluice gates appear to be properly maintained and operational.	39.026350 ° -121.726870 °	39.026350 ° -121.726870 °	15

Photo shows one sump with vegetation present.

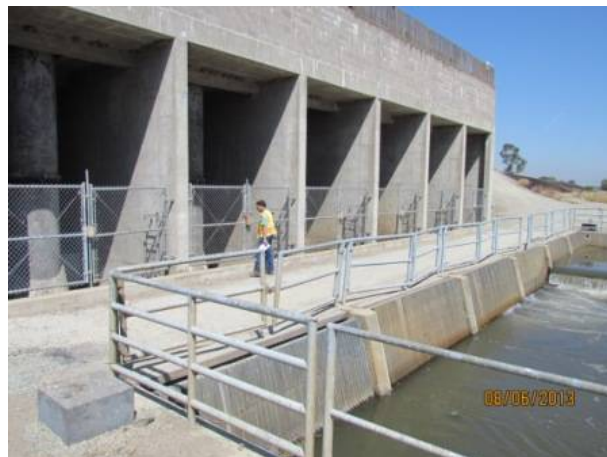
mkhashch_t_20130815_115.JPG

Photo shows row of trash racks (six).

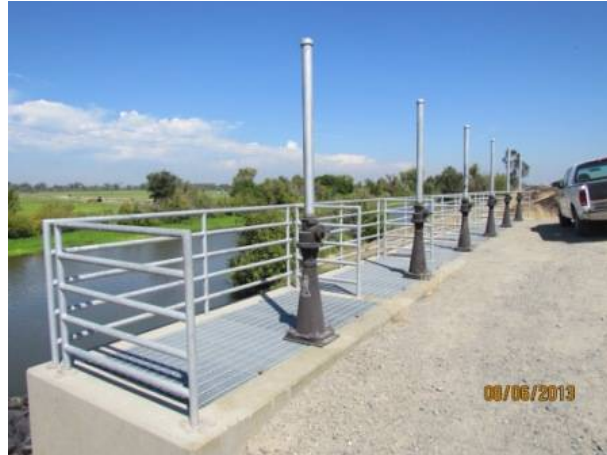
mkhashch_t_20130815_116.JPG

Photo shows controls for sluice gates.

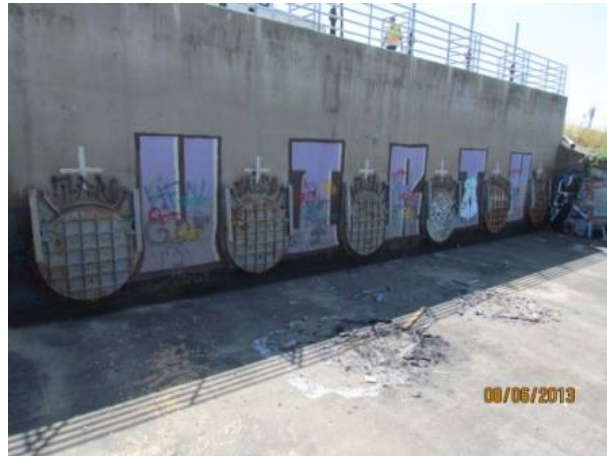
mkhashch_t_20130815_117.JPG

View of the flap gates.

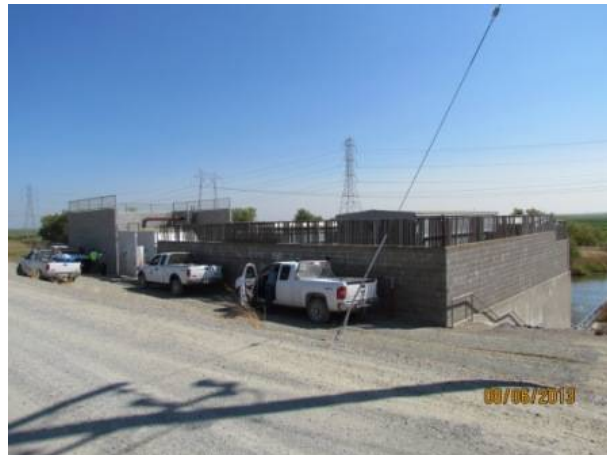
mkhashch_t_20130815_118.JPG

Photo shows masonry block wall which encloses the site.

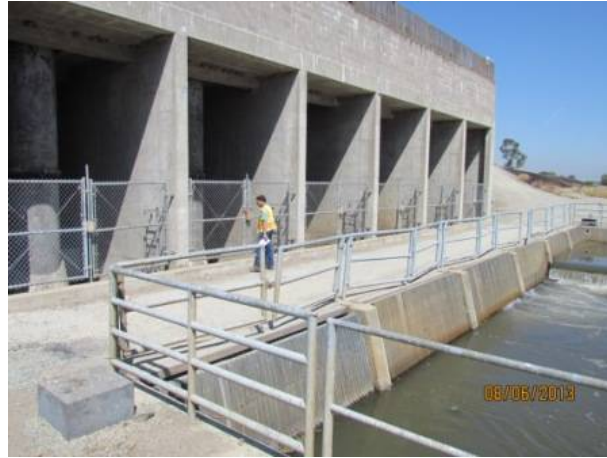
mkhashch_t_20130815_119.JPG

View of the intake structure.

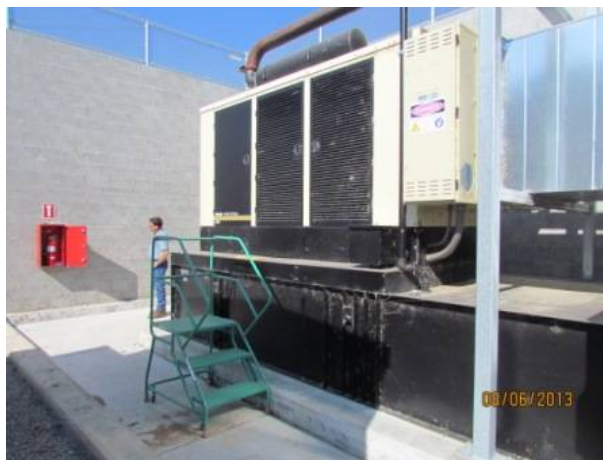
mkhashch_t_20130815_104.JPG

View of the emergency backup generator with accessible fire extinguisher.

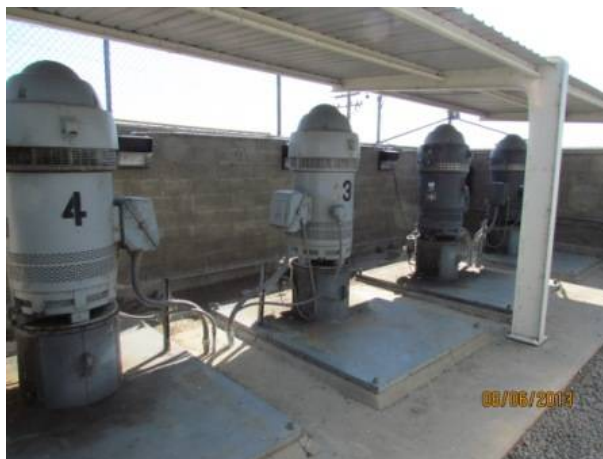
mkhashch_t_20130815_105.JPG

Photo shows motors which appear to be maintained and in good working condition.

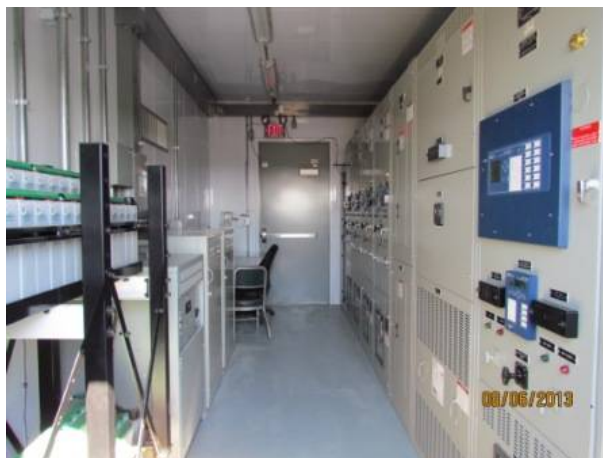
mkhashch_t_20130815_106.JPG

View of the new control room.

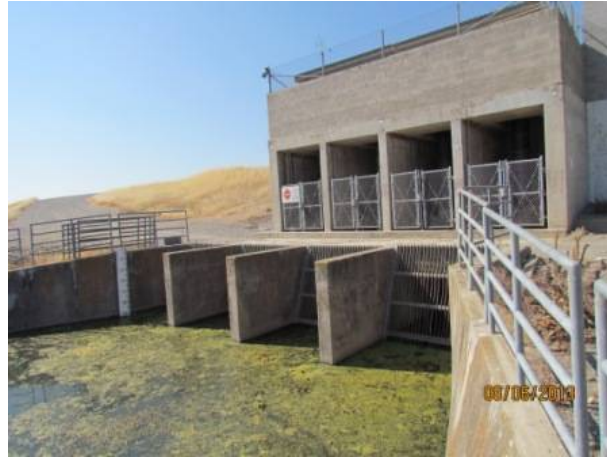
Levee Mile Report Line	12
Start Levee Mile	0.00
End Levee Mile	0.00
Location	
Category	Pump Stations
Item	Trash Racks
Photo shows trash rack free of debris and other material.	
mkhashch_t_20130815_107.JPG

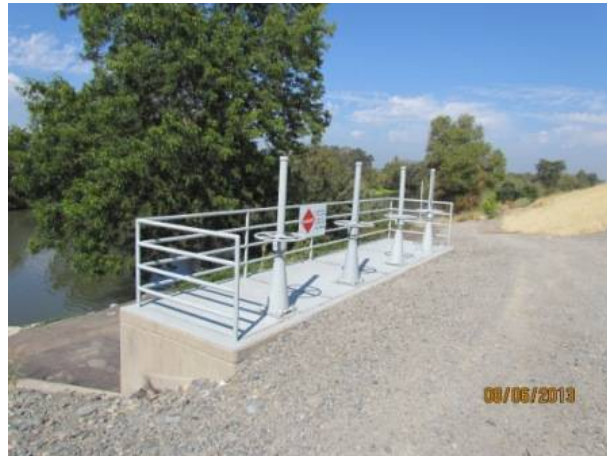
Levee Mile Report Line	16
Start Levee Mile	0.00
End Levee Mile	0.00
Location	
Category	Pump Stations
Item	Manual Gate Operators
Photo shows manual gate operators.	
mkhashch_t_20130815_108.JPG

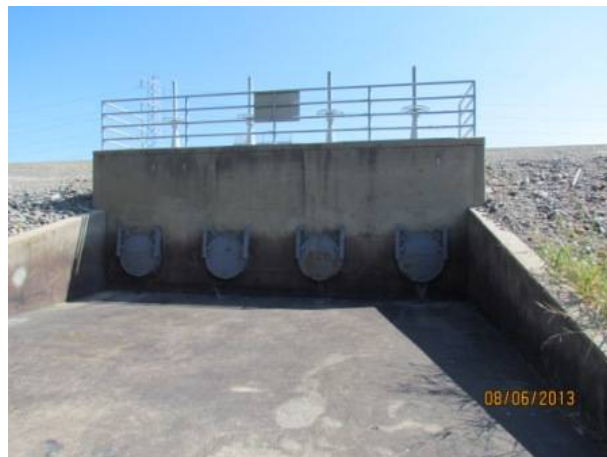
Levee Mile Report Line	18
Start Levee Mile	0.00
End Levee Mile	0.00
Location	
Category	Pump Stations
Item	Flap Gates
Photo shows flap gates and concrete outfall structure.	
mkhashch_t_20130815_109.JPG

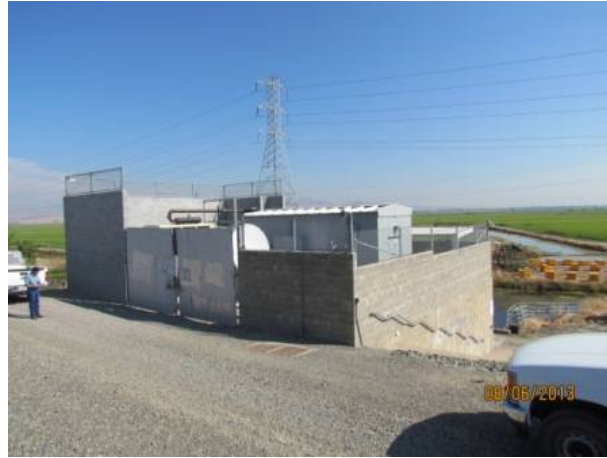
Levee Mile Report Line	20
Start Levee Mile	0.00
End Levee Mile	0.00
Location	
Category	Pump Stations
Item	Security Fencing
Photo shows masonry brick wall which encloses the entire structure.	
mkhashch_t_20130815_110.JPG

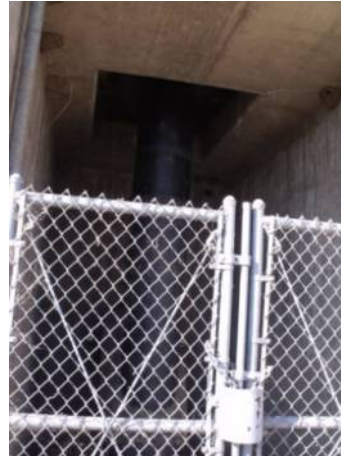
Levee Mile Report Line	21
Start Levee Mile	0.00
End Levee Mile	0.00
Location	
Category	Pump Stations
Item	Intake and Discharge Pipes
08/24/2011 Photo shows Intake pipe, typical.	
mkhashch_t_20130730_081.jpg

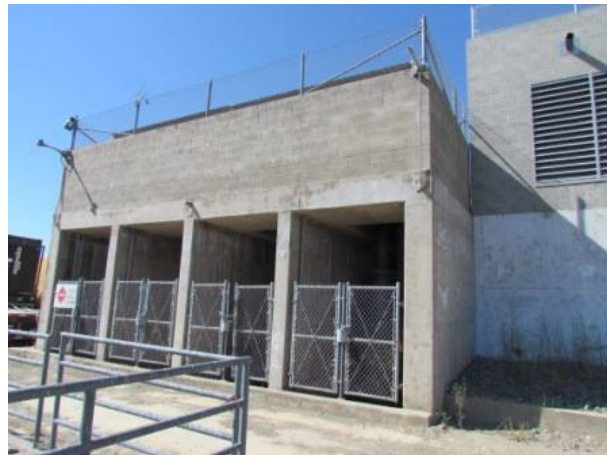
Levee Mile Report Line	21
Start Levee Mile	0.00
End Levee Mile	0.00
Location	
Category	Pump Stations
Item	Intake and Discharge Pipes
07/20/2012 Photo shows Intake structure.	
mkhashch_t_20130730_082.JPG

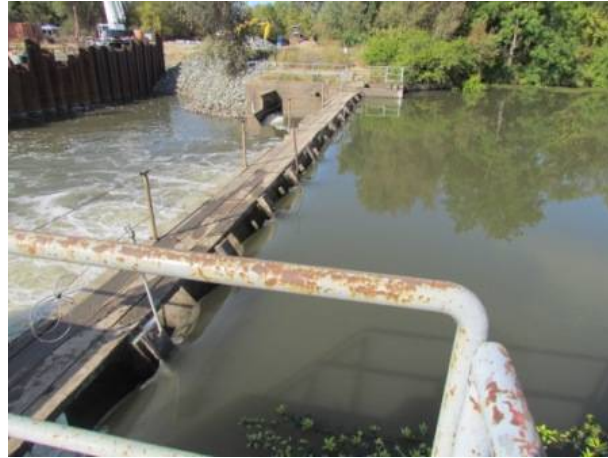
mhoffman_t_20130812_058.JPG

The view from upstream of the Sutter Bypass Weir #2.

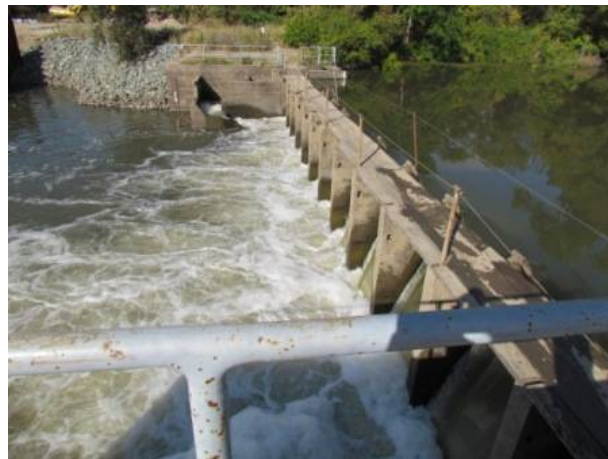
mhoffman_t_20130812_059.JPG

The view from downstream of the Sutter Bypass Weir #2.

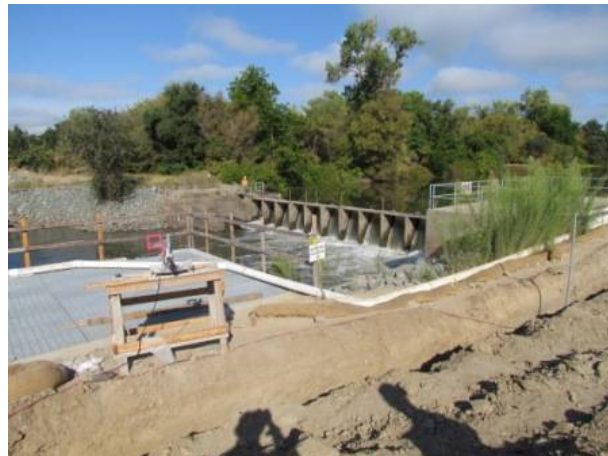
mhoffman_t_20130812_061.JPG

This is a view of the Sutter Bypass Weir #2.

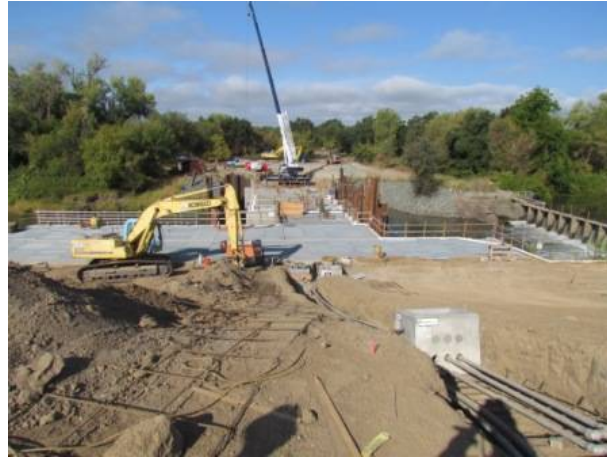
mhoffman_t_20130812_060.JPG

The replacement weir.

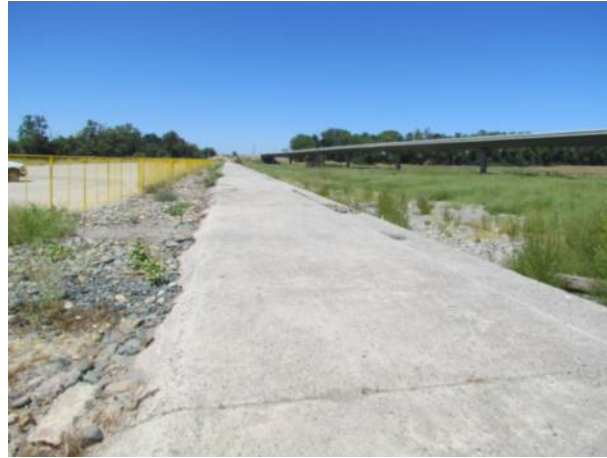
Levee Mile Report Line	1
Start Levee Mile	0.00
End Levee Mile	0.00
Location	
Category	Structures
Item	Photo Documentation
This view is of the Tisdale Weir from the right bank levee.	
mhoffman_t_20130807_045.JPG

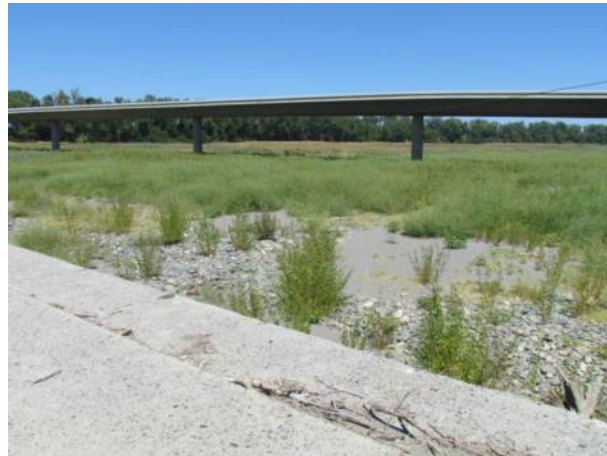
Levee Mile Report Line	1
Start Levee Mile	0.00
End Levee Mile	0.00
Location	
Category	Structures
Item	Photo Documentation
The view downstream from the structure.	
mhoffman_t_20130807_049.JPG

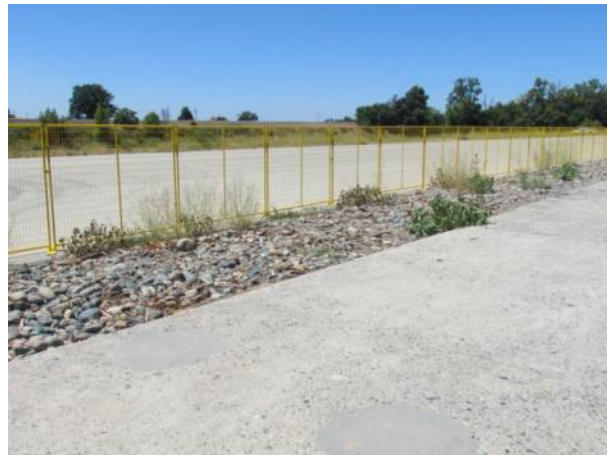
Levee Mile Report Line	1
Start Levee Mile	0.00
End Levee Mile	0.00
Location	
Category	Structures
Item	Photo Documentation
The view upstream from the structure.	
mhoffman_t_20130807_050.JPG

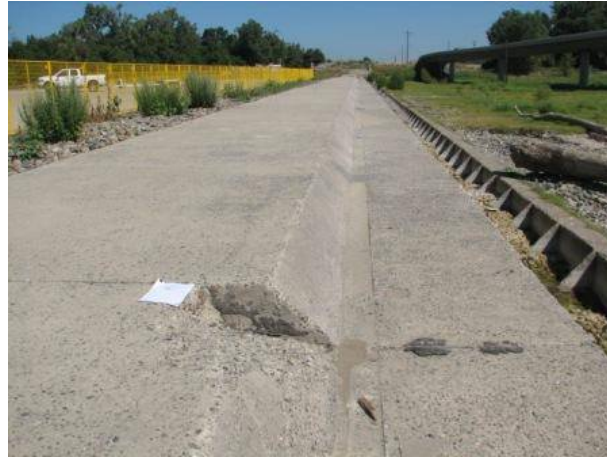
mhoffman_t_20130723_029.jpg

This photo shows some surface damage.

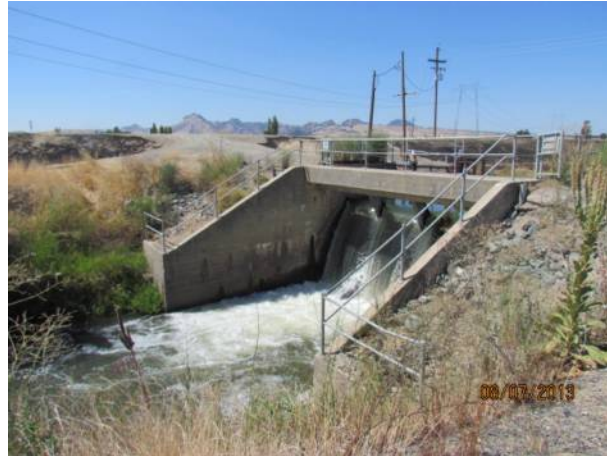
Levee Mile Report Line	3
Start Levee Mile	0.00
End Levee Mile	0.00
Location	
Category	Structures
Item	Erosion / Bank Caving
View of the downstream side of the Wadsworth Canal Weir No. 4 showing erosion along channel.	
rduffey_t_20130819_010.JPG

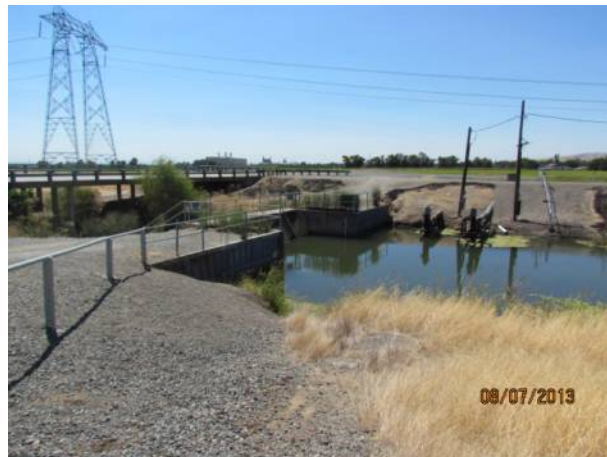
Levee Mile Report Line	23
Start Levee Mile	0.00
End Levee Mile	0.00
Location	
Category	Structures
Item	Photo Documentation
View of the upstream side of the Wadsworth Canal Weir No. 4.	
rduffey_t_20130819_011.JPG
